### 3.8 Building Assessments

Lehigh Valley International Airport  
Master Plan Update

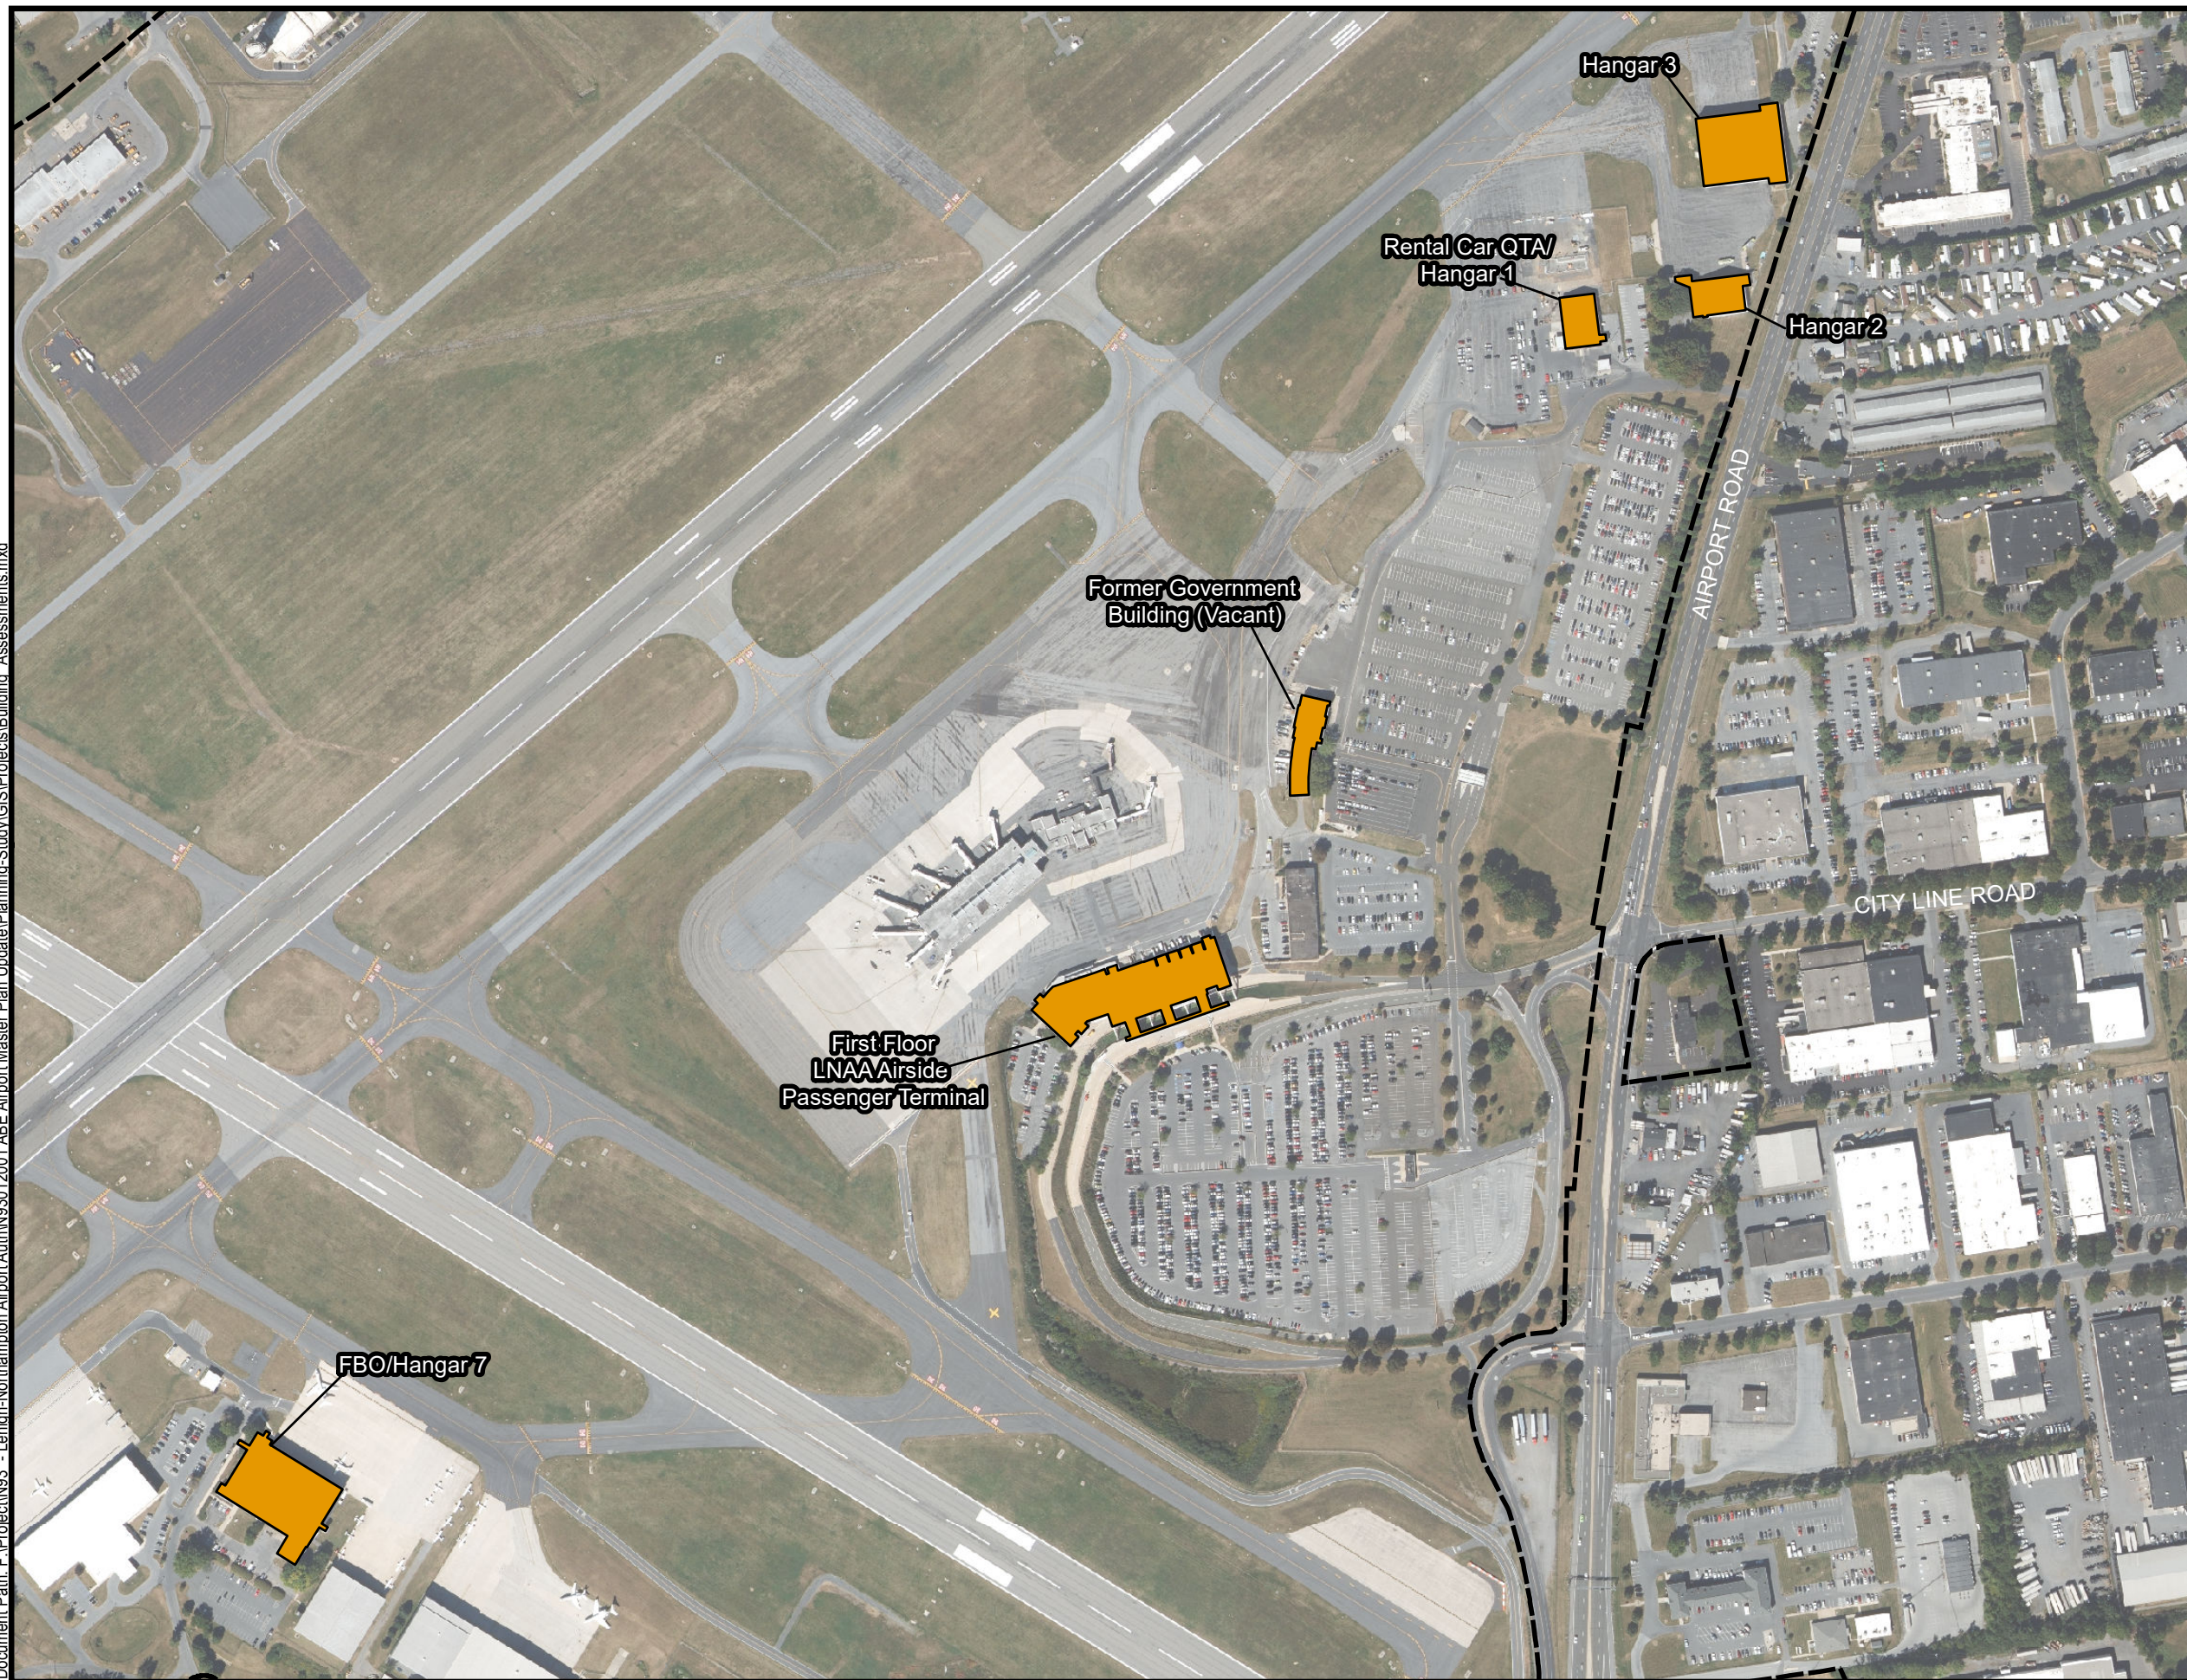
Figure 3.8.1

These buildings are depicted in **Figure 3.8.1** and summarized in **Table 3.8.1**. Costs indicated in this table are preliminary estimates only and will be reexamined during the development of the capital improvements program. The full building inventory assessment report is available in **Appendix C - Inventory Materials**.

### Building Assessments
